RECONNAISSANCE GEOLOGICAL REPORT OF SMT. SOVI DEVI W/O
SHRIBHAGAT RAM FOR THE PROPOSED CONSTRUCTION OF OWNER
DRIVEN CONSTRUCTION HOUSING (ODCH)
VILLAGE-ANGODA, TEHSIL- PUROLA, DIST.- UTTARKASHI
KHASRA NO.- 240&AREA -0.143 ha.

Date of Inspection: 28-12-2013

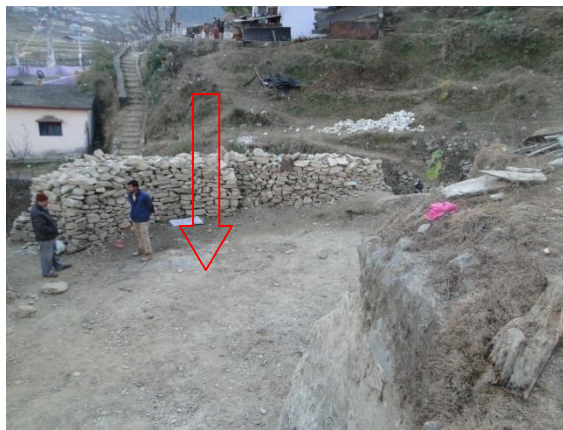
The proposed site situated on the overburden which is manmade flat hill terrace. At 50m horizontal distance in the east direction on the right bank of Kamal river, at site head in west direction Angora Khadd perennial nala is present, 1-2m approximate thickness of overburden, in overburden phyllite fragments 1-5cm in size with fine grain brownish clayey soil matrix with less vegetation. Bedrock schistose and gneisses has been exposed surrounding of the site.

Close view of the propose site

At the site uphill slope is 30°-35° and downhill slope is 25°-30° towards E direction. In-situ schistose gneiss with inclination of bed 5°-10° in N direction and joints are J1 is dipping 90° in S 50° E direction, J2 is dipping 75° in N direction, J3 is dipping 90° in S 80° E

direction. Below the site 30-40m towards river terrace T1 located on flat cultivated man-made terrace. The toe of the land vertical retaining wall is present.

1. Inclined retaining wall at the uphill side with depth of foundation more than the foundation depth of the house, with provisions of weep holes and sufficient gap of about 0.5-1.0m in between the backside retaining wall and the proposed construction should be constructed. And also, proper drainage system between the retaining wall and the wall of house should be developed.

2. The surface drainage should be properly planned through lined drain/pipe, so both, rainwater from uphill side as well as waste water from the existing houses to be release safe place at down-hill along a channel.

3. Inclined retaining wall with step at the toe of the proposed site with provision of weep holes at specific distance should be re-constructed.
4. Massive plantation of trees, bushes and grasses which can hold the soil mass and retained the debris with dense and long rooted, wide/broad leafed flora must be done to protect the soil erosion and minimize the surface erosion of the subsurface rocks.
